EnverBridge Abnormal Connection & Solutions

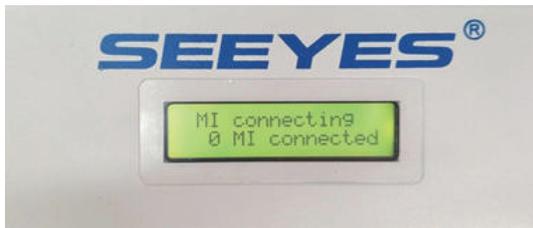
Case 2:

The display screen consistently shows “MI connecting” on the first line and “0 MI connected” on the second line.

This message indicates that EnverBridge didn't receive any transmission signal from the microinverters. The reason can be signal interference.

Note: Please make sure that the microinverters are connected in the same phase as this EnverBridge.

1. Confirm whether the microinverter(s) monitored by this EnverBridge is(are) in normal conditions (LED light flashing green).
 2. If the EnverBridge is installed too far away from the microinverter(s), the signal transmission would be too far to be effective. Try installing the EnverBridge nearer to the microinverter(s), better within 50m. The shorter the distance is, the better signal it would get.
 3. Check whether there is other PLC appliance causing interfering signal. When the EnverBridge is directly plugged into the wall outlet, avoid using other PLC appliances on the same line.
- If EnverBridge still function abnormally after you have taken the steps above, please contact your local distributor or Envertech (tech@envertec.com) directly for assistance.
